THE OHIO HOME INSPECTIONS COMPANY

**Property Inspection Report
Prepared for John & Jane Sample**

**0000 Dayton Ave
Cincinnati, OH 45222**

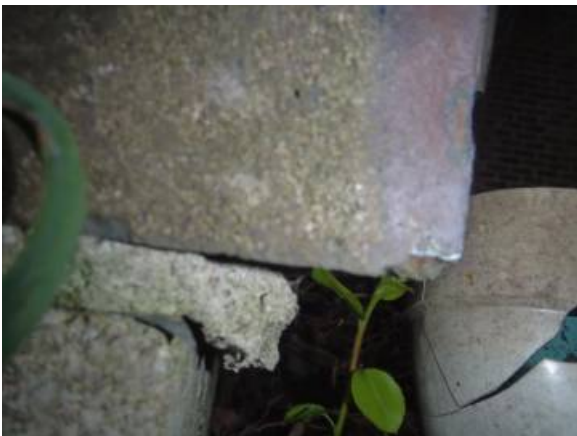
WALL SURFACE DEFECTS The wall brick had excessive overhang at foundation wall. A qualified Contractor should be called to make corrections as needed.

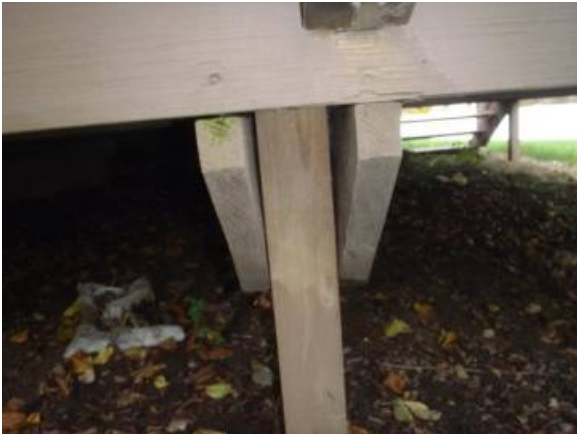
The deck girders were not properly attached to the posts and the deck support posts were undersized. A qualified Contractor should be called to make corrections as needed.

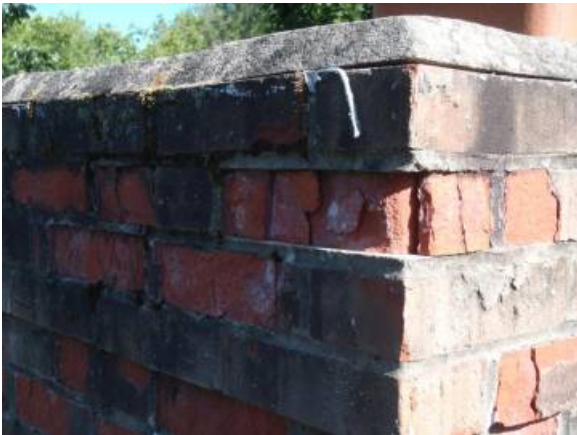
Deteriorated mortar joints and damaged bricks were viewed. A qualified Contractor should be called to make corrections as needed.

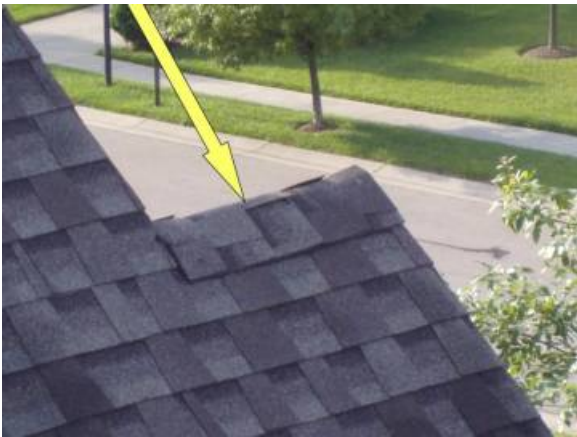
ROOF ACCESS:	Walked on roof.
ROOF TYPE:	Cross Gable, Hip, Shed.
MATERIALS:	Composition shingles. Elastomeric/Rubber Roofing.
CONDITION:	Condition was serviceable with signs of normal wear with the exception of the following defects.
ROOF COVERING MATERIAL DEFECTS:	Improper installation was found at the ridge. A qualified Roofing Contractor should be called to make corrections as needed.

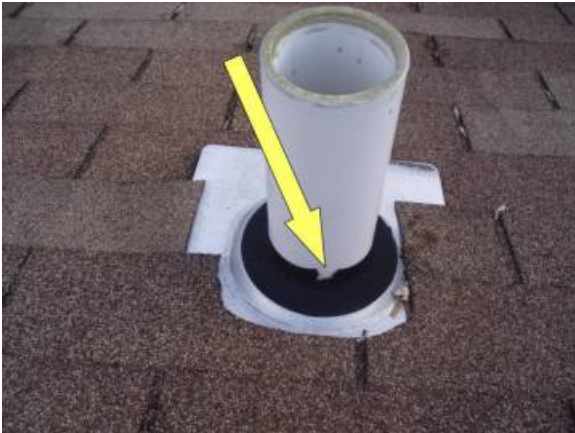
CONDITION:	Flashings were in overall serviceable condition with the exception of the following defects.
PLUMBING VENT FLASHING DEFECTS	The rubber boot was cracked. A qualified Roofing Contractor

should be called to make corrections as needed.

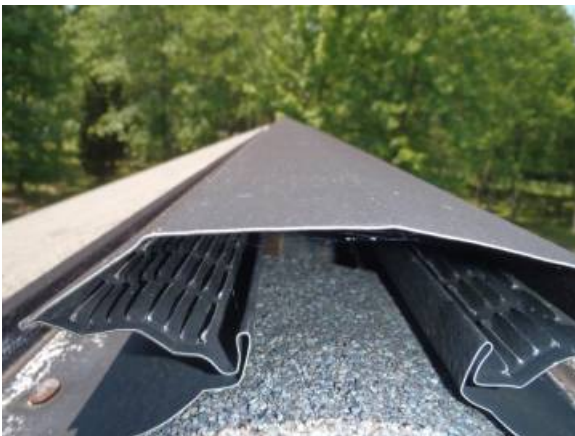
TYPE:	Ridge vent.
NUMBER OF VENTS:	4
CONDITION:	Vents were found in satisfactory condition with the exception of the following.
ATTIC VENT DEFECTS:	The upper LH ridge vent was missing an end cap. It is recommended to have a qualified Roofing Contractor make corrections as needed.

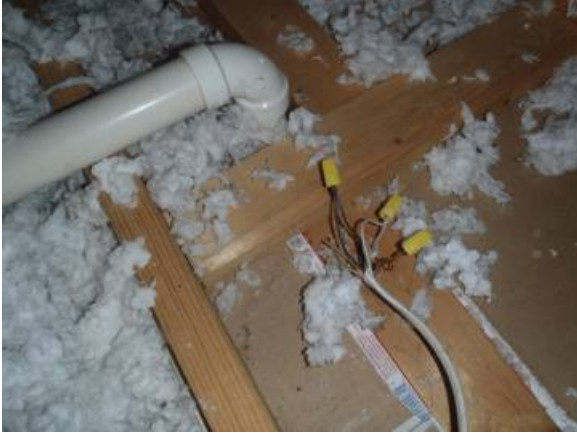
INSULATION DEFECTS: Insulation had been disturbed and good coverage was no longer present in some areas. A qualified Contractor should be called to make corrections as needed.

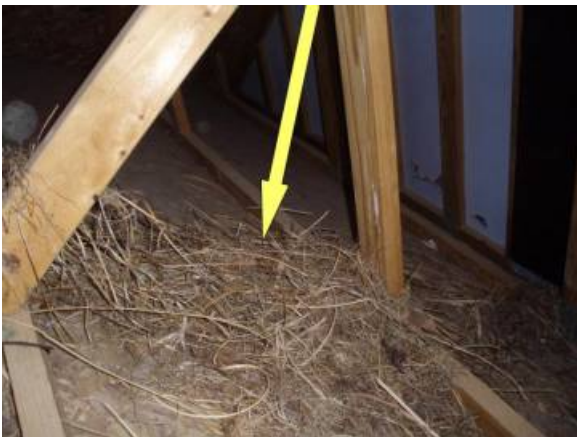
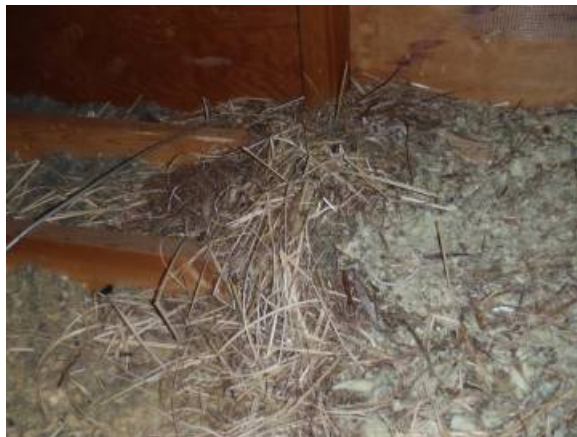
Evidence of current or prior rodent activity viewed. It is recommended to have treatment carried out by a licensed exterminator & eliminate any Rodent access points.

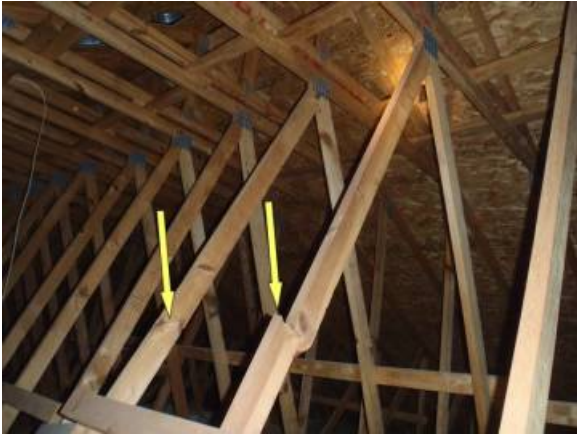
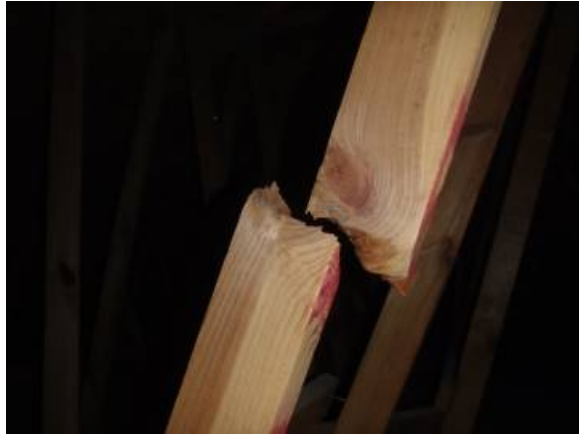
Damaged truss webs were viewed. It is recommended to contact a Structural Engineer for further evaluation then a qualified Contractor should be called to make corrections as needed.

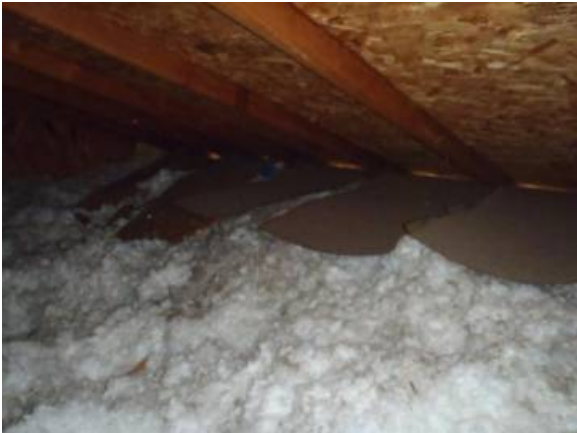
Some rafter vents had fallen out of place. A qualified Contractor should be called to make corrections as needed.

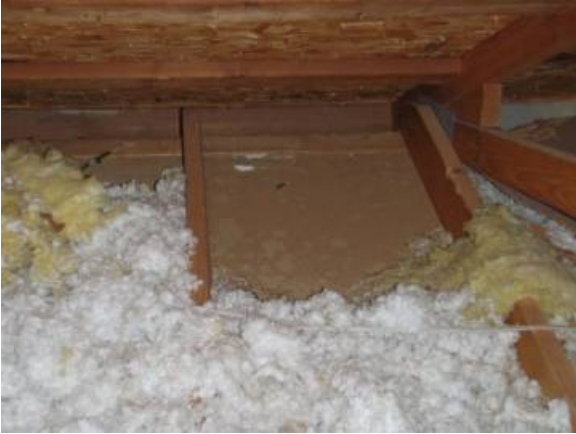
Insulation has been blown back at the eaves in some areas. A qualified Contractor should be called to make corrections as needed.

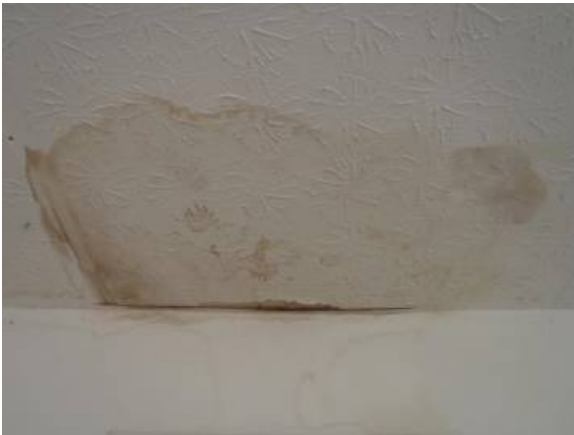
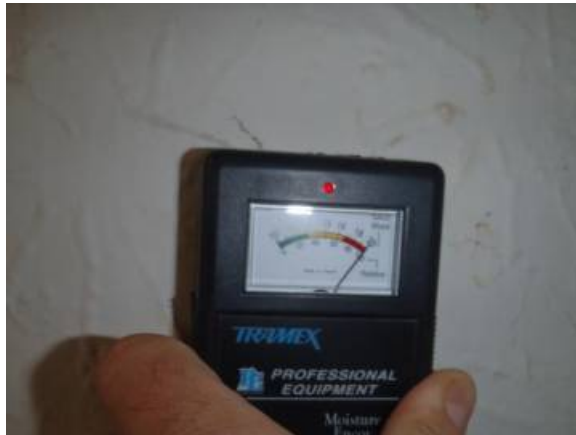
CEILING DEFECTS: Staining was viewed on the ceiling surface, checked with a moisture meter and resulted in a measurement indicating high moisture content. This is an indication a current leak is present. Have a qualified contractor make corrections as needed.

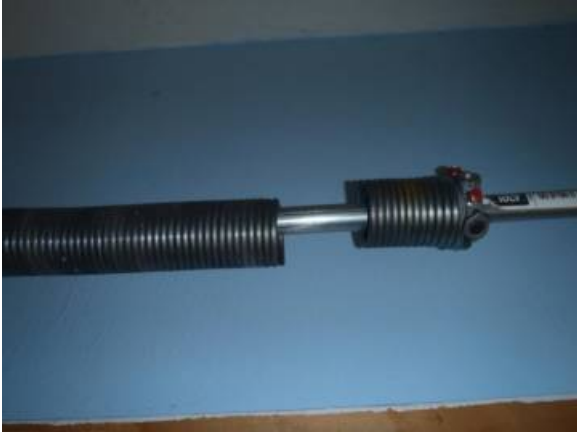
GARAGE DOOR DEFECTS: The garage door had a damaged torsion spring. Have a qualified Contractor make corrections as needed.

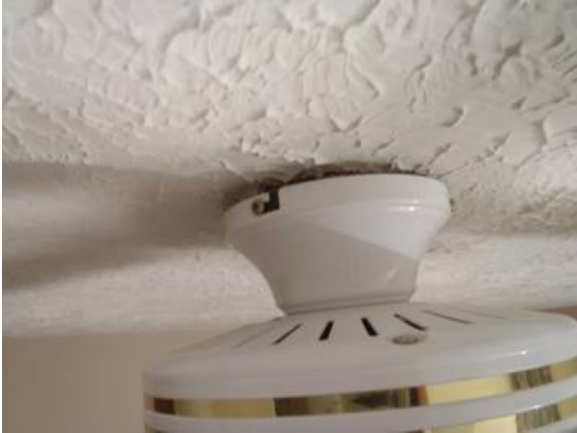
ELECTRICAL COMPONENT DEFECTS: The ceiling fan was loose at the ceiling & is improperly installed.
Have a qualified Electrical Contractor make corrections as needed.

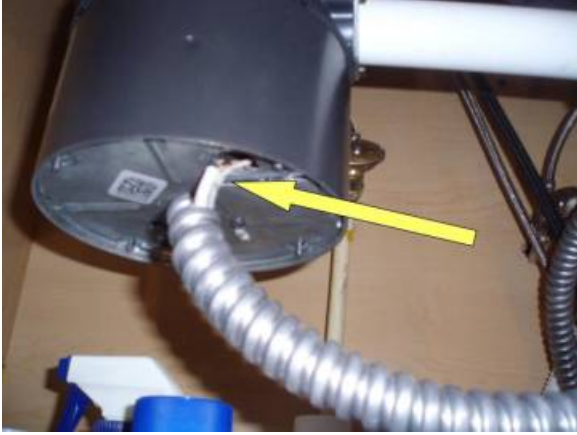
GARBAGE DISPOSAL DEFECTS: The garbage disposal power wire was not clamped at the unit. A qualified Contractor should be called to make corrections as needed.

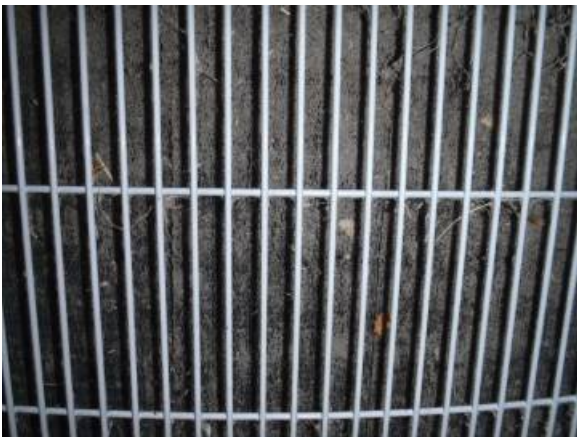
TYPE:	Air Conditioning.
LOCATION OF UNIT:	Exterior rear side of structure.
MANUFACTURER:	Carrier.
APPROXIMATE AGE:	8 years.
POWER SOURCE:	220 Volt.
REFRIGERANT LINES:	No defects viewed.
UNIT CONDITION:	Performed its designed & intended function with the exception of the following.
COMPRESSOR UNIT DEFECTS	Some of the compressor unit cooling fins were clogged due to lack of maintenance. Contact a qualified HVAC contractor for corrections as needed.

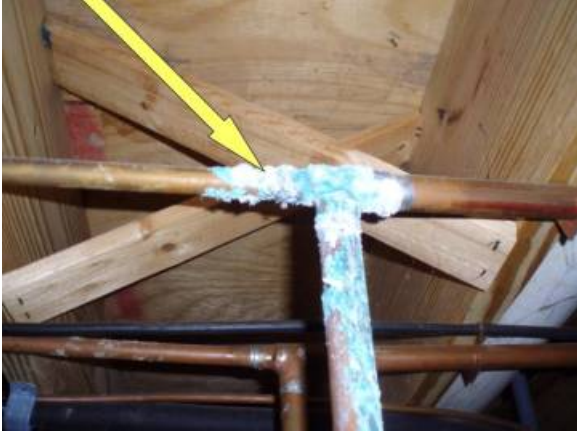
Pitting corrosion was viewed & may lead to pin-hole leaks in the future. Have a qualified Plumbing Contractor make corrections as needed.

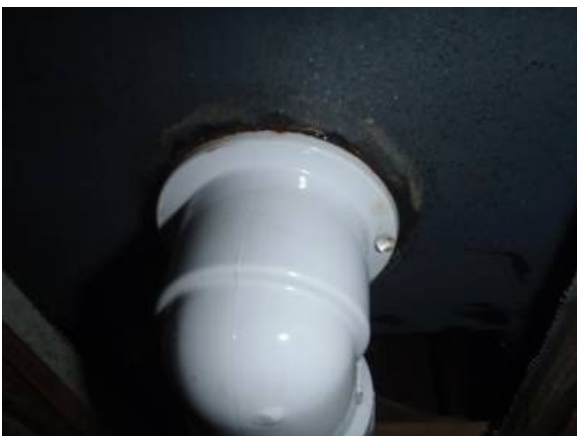
A leak was viewed at the bathtub drain pipes. Have a qualified Plumbing Contractor make corrections as needed.

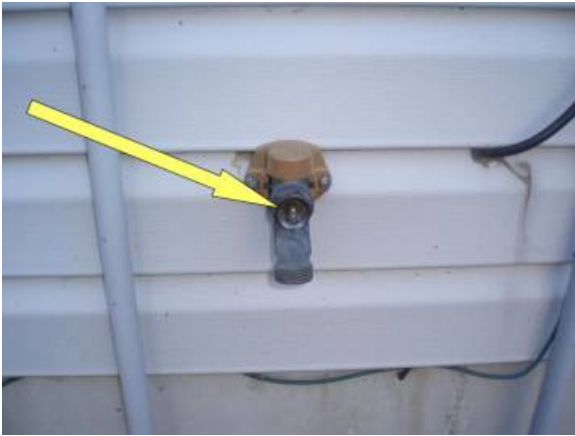
The hose faucet handle was missing. Have a qualified Plumbing Contractor make corrections as needed.

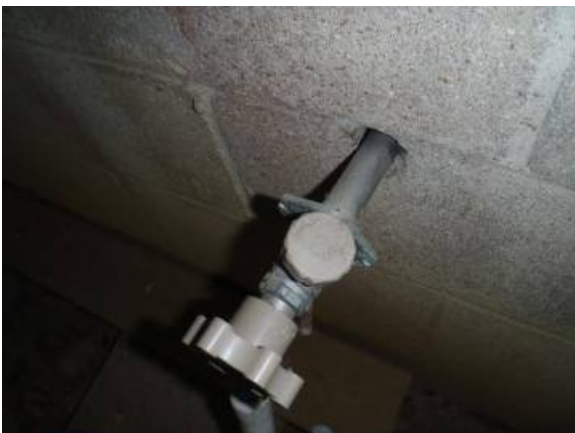
The hose faucet was not properly attached to structure. Have a qualified Plumbing Contractor make corrections as needed.

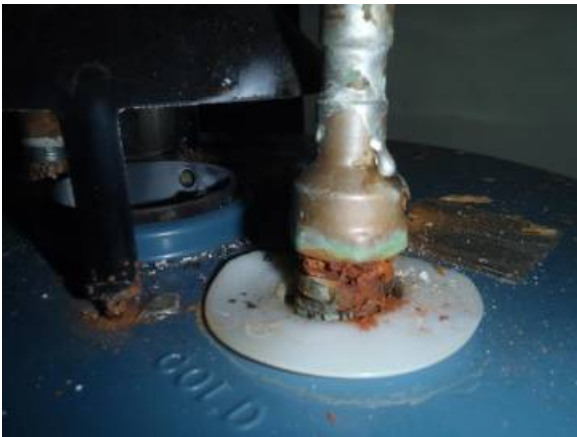
WATER HEATER DEFECTS: Dissimilar metal corrosion was viewed at pipe connections indicating dielectric fittings were not in place or were inadequate. Have a qualified Plumbing Contractor make corrections as needed.

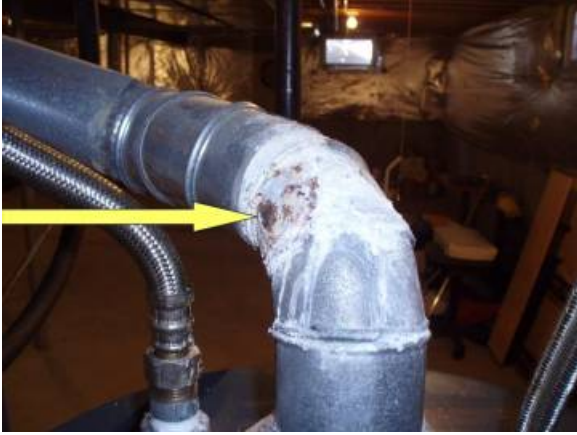
VENT DEFECTS: The vent pipe was corroded. Have a qualified Plumbing Contractor make corrections as needed.

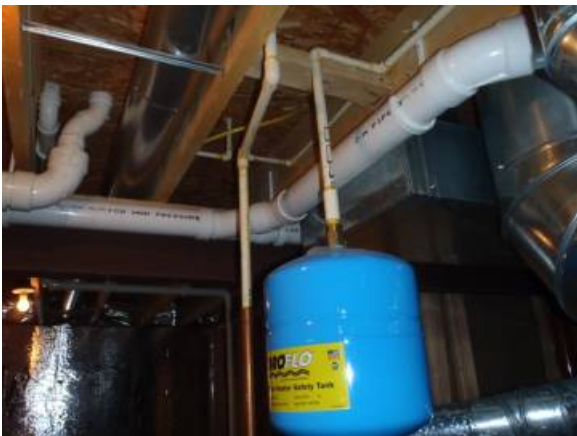
The expansion tank was not properly supported & may cause damaged to the plumbing pipes over time. Have a qualified Plumbing Contractor make corrections as needed.

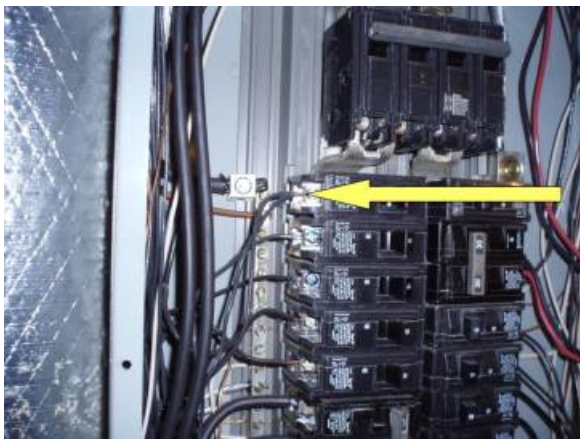
PANEL DEFECTS: Multiple wires were connected to a single lug on a circuit breaker where only one wire should be connected. Have a Qualified Electrical Contractor make corrections as needed.

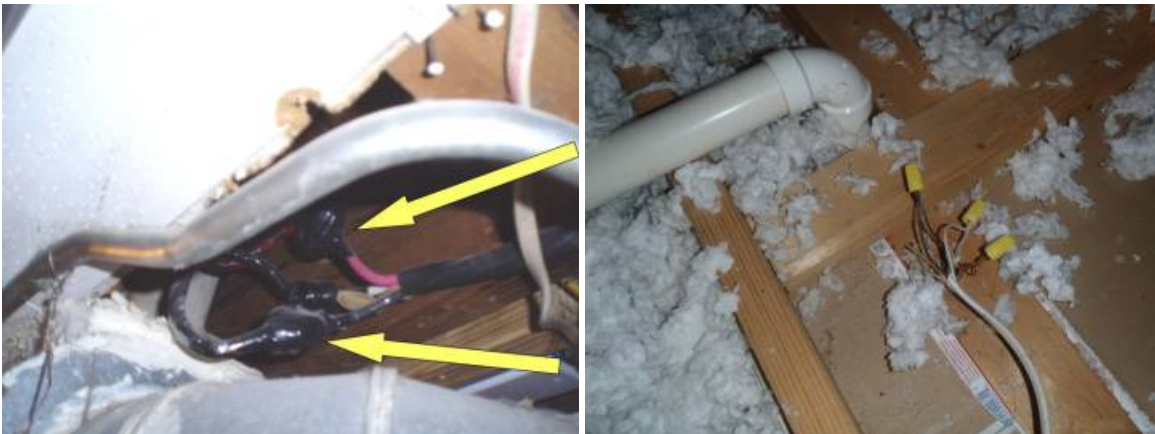
BRANCH WIRING DEFECTS: Splices were viewed that were not made within a junction box in the basement and the attic. Have a qualified Electrical Contractor make corrections as needed.

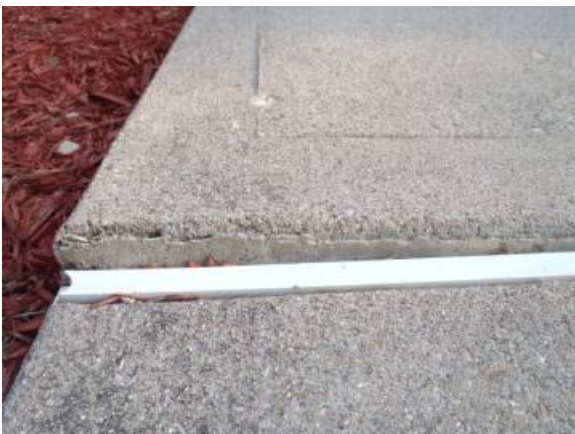
SIDEWALK DEFECTS: The surface had a raised/settled condition that presented a trip hazard. Have a Qualified Contractor make corrections as needed.

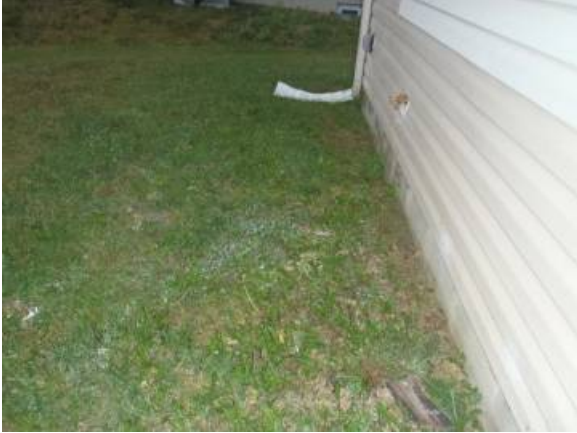
GRADE DEFECTS: Soils appeared to have insufficient slope for proper drainage on the LH side of the structure, slope should fall away from the foundation at a minimum of 1/2 inch per foot and extend at least 10 feet away from the foundation. Have a qualified Landscaping Contractor make corrections as needed.

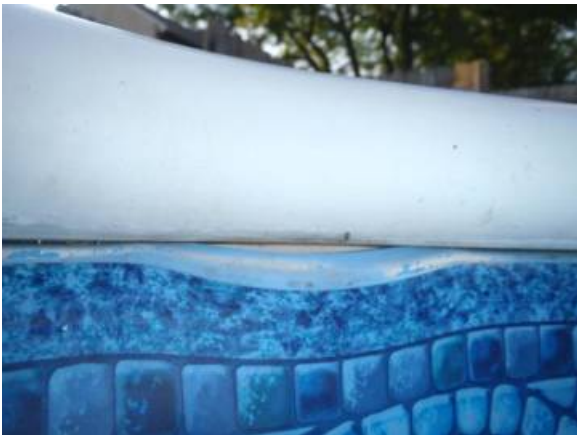
The pool liner was pulled out of the retaining ring in some areas. A qualified pool contractor should be called to make corrections as needed.

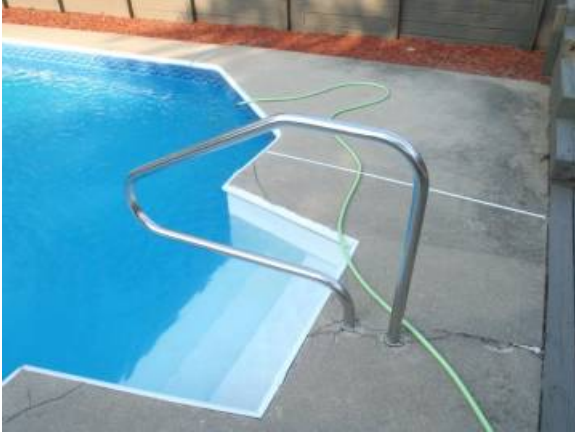
The railings were loose. A qualified Pool Contractor should be called to make corrections as needed.

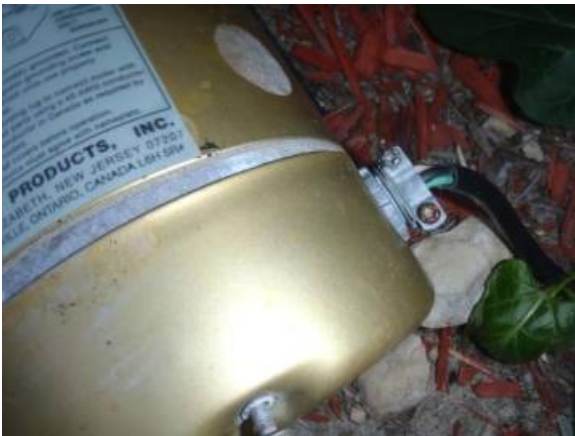
The wire clamp (strain relief) was loose at the pump housing. A qualified Pool Contractor should be called to make corrections as needed.

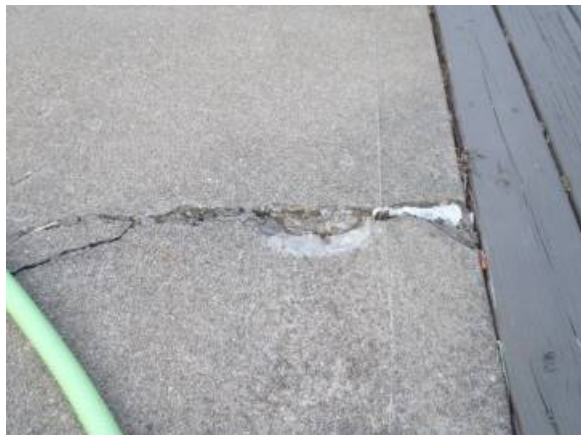
POOL DECKING DEFECTS: The surface materials had an extensive cracking condition and presented a trip hazard. Have a qualified Contractor make corrections as needed.
